**Forensic Building Science, Inc.**

# Fire Damage Report

**The Metropolitan**

2700 7th Avenue South, Birmingham, AL 35233

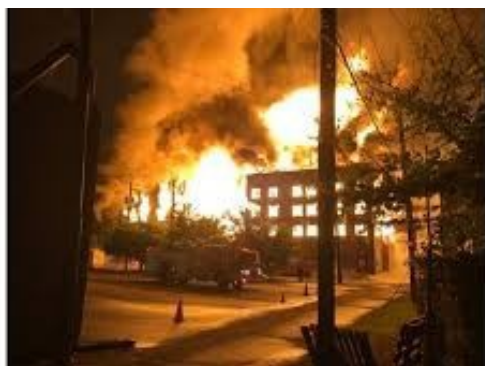
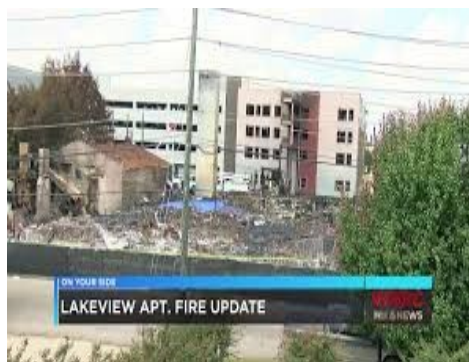
News WKRG Photo

News WBRC Photo

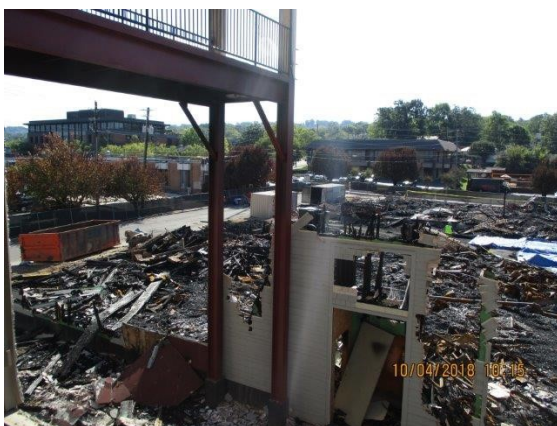
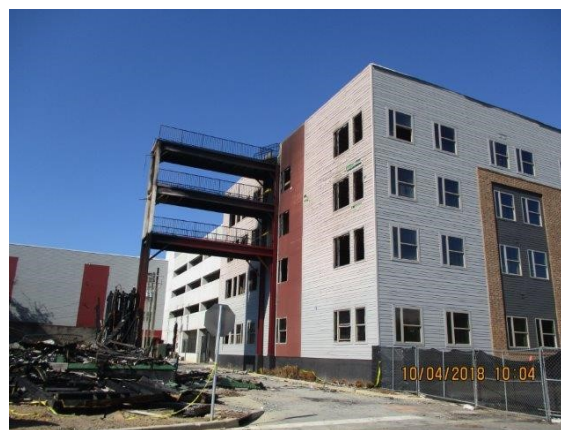
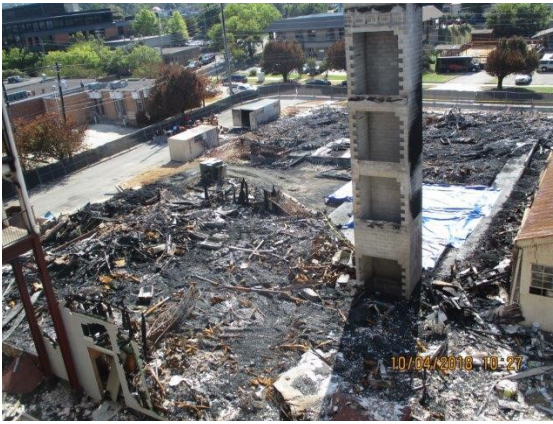
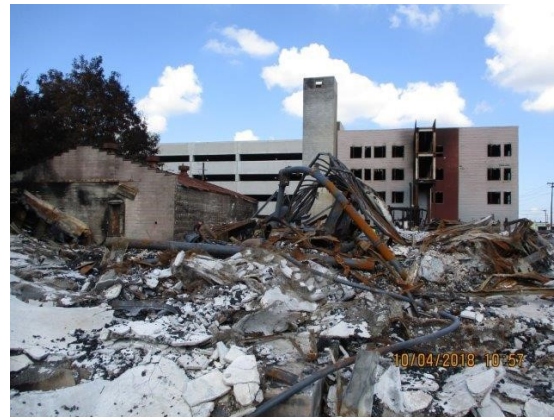
Pictures provided by the Howarth Group, obtained from the owner's group.
